“ENGINEERING FOR THE PALLIATIVE RECONNECTION OF OCLC PIPELINE AT PK 133+000, IN THE SECTOR OF LA CHINA, NORTE DE SANTANDER

E.D. INGEOTECNIA SAS - CENIT

ABSTRACT

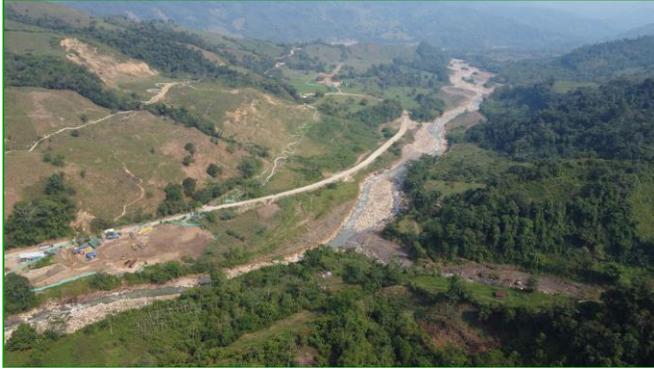
Figure 1. General aerial photo of the landslide La China PK 133+000.

In the Cortinas area, there is a sector that, along four kilometers, is delimited between the escarpments that reach a height of six hundred meters, and the foot of its slopes that finally adjoin the left bank of the La China ravine, with an average height of 484 m.s.n.m. This sector, which faces the urban center of Samoré and the reserve areas of the Uwa indigenous community, both located on the right bank of the same ravine, is characterized by presenting, differentially but periodically (approximately every 20 years), movements of mass removal, landslides, which have constituted a permanently latent geotechnical threat for the inhabitants, the houses and existing constructions; such as homes, power towers, a primary road, as well as the infrastructure for hydrocarbons, one for gas and another that transports oil owned by Cenit. Historically, geotechnical events materialized in landslides have been known where the aforementioned hydrocarbon pipelines have been affected, generating deformation, sometimes even breaking with the immediate consequence of the suspension of the corresponding flow and environmental contamination. The last event of this nature occurred in August 2021 and the previous one in 1988.

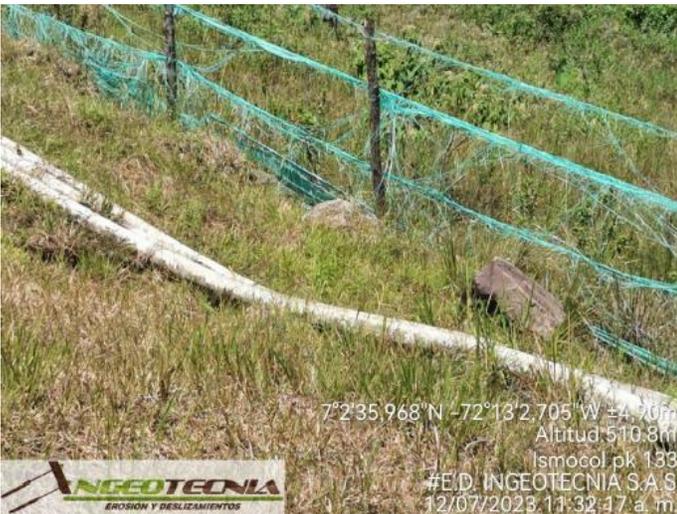
Figure 6 Typical model of rock falls, evidence of falls, and OCLC protective dike work.

For the alternative of installing the pipeline on the surface, it was necessary to analyze the risk of possible rock falls that could impact the pipeline, affect it and even break it, given that the material moved has a large number of rock blocks and evidence of rocks was identified, of large size close to the area of the provisional flexible pipe.

The results of the models defined the possible trajectories and the maximum height in the line immediately above the position of the pipe, which yielded a value of 1.5 meters in order to define the size of the protection structure, which consists of a soil dam reinforced with high modulus polyester geotextiles with bags of soil cement and protected with a casing covering the rock impact zone with a Fortshield-type geotextile.
